**GMC Motorhome Premium Grade Stainless Steel
PARKING BRAKE CABLE ASSEMBLIES**

Pictorial of GMC Park Brake Kit Contents :

GMC Motorhome Premium Grade Stainless Steel PARKING BRAKE CABLE ASSEMBLIES

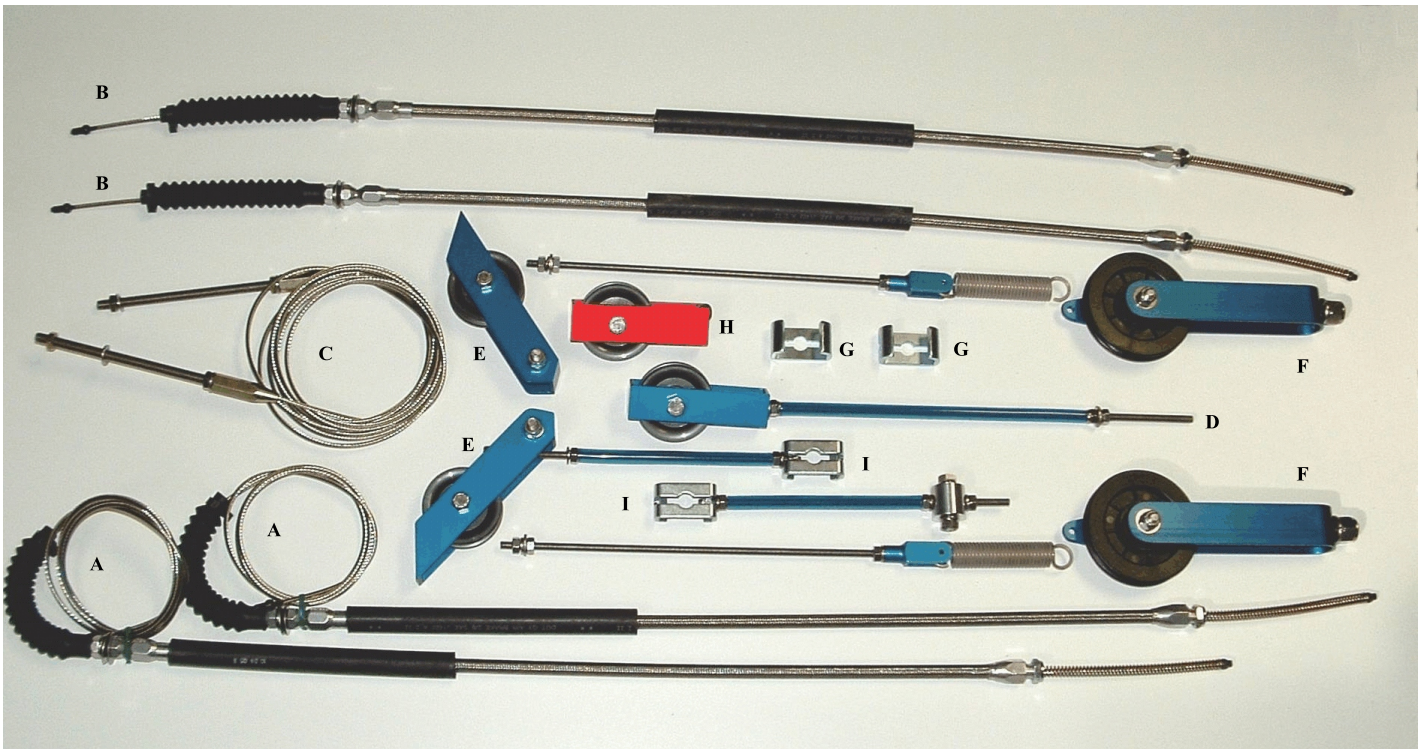
A - Rear bogie cable & conduit (L + R)

B - Front bogie cable & conduits (L + R)

C - Intermediate Cable

D - Intermediate cable guide pulley

E - Intermediate cable thru- frame
Routing pulleys (L + R)

F - Equalizer / Adjuster pulleys (L + R)

G - GMC - OEM cable connectors (L + R)

H -Park brake handle cable EQ pulley

I - Equalizer / Adjuster pulley yoke
adapters for disc or single drum
brake applications (L + R)

Items “B” and “G” are omitted in the kits meant for disc brake and / or rear drum park brake only (ie. Using the two rear most wheels for park brake application.) Item “I” is included in the kits designated as “Disc Kits” and will replace the equalizer / adjuster pulley in the adjuster yoke if desired by the coach owner.

- **A - 2** -Stainless steel braided cable conduits with the long stainless core wire, These will be for the two rear bogie assemblies.
- **B - 2** - Stainless steel braided cable conduits with the short stainless core wire, These will be for the two front bogie assemblies.(Omitted in disc kits)

- **C - 1** - Intermediate cable assembly with adjuster unions and 5 inch, NF threaded studs c/w jam nut and lock washer, for 260 series GMC motorhome, see later instructions for 230 series application.

- **D - 1** - Intermediate cable guide pulley assembly, this will attach to the right rear side of the transmission crossmember where the previous wire loop hook guide was attached thru a 9/32" dia. hole.

- **E - 2** - Thru-frame routing pulley assemblies, one **left** and one **right**, these will replace the S-Hook guide that routes the intermediate cable thru the frame rail slots on either side of the coach.

- **F - 2** - Anodized aluminum equalizer / adjuster pulley assemblies c/w intermediate cable retract springs and tension adjusters and (2) yoke adapters for disc kits.

- **G - 2** - GMC - OEM type cable connectors to join the front and rear bogie cables together at the top of the equalizer / adjuster pulley assembly on each side of the coach, 2 cable connectors attached to 10.5" SS -1/4" threaded rod to be used for cable anchor devices in the “Disc Kits”

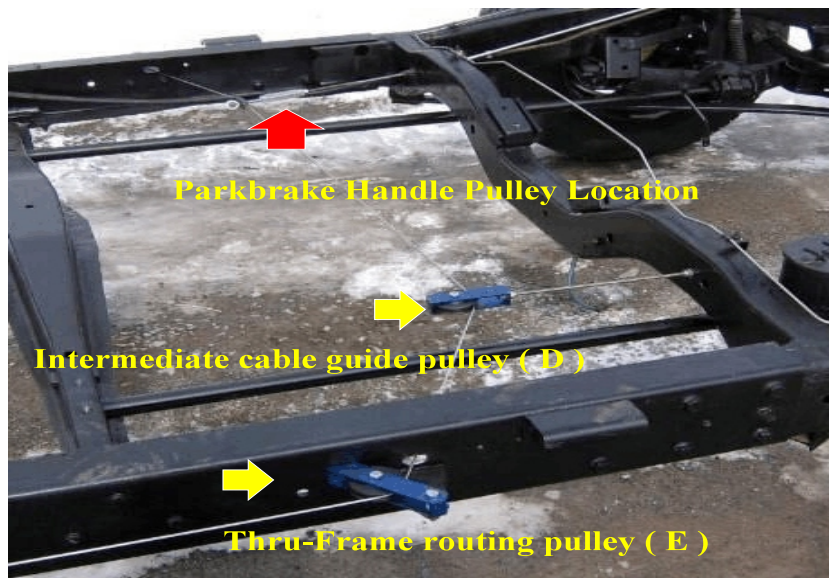
Top photo : Showing ‘Thru frame ‘ pulley and intermediate cable routing pulley and location of ‘red’ parkbrake handle pulley

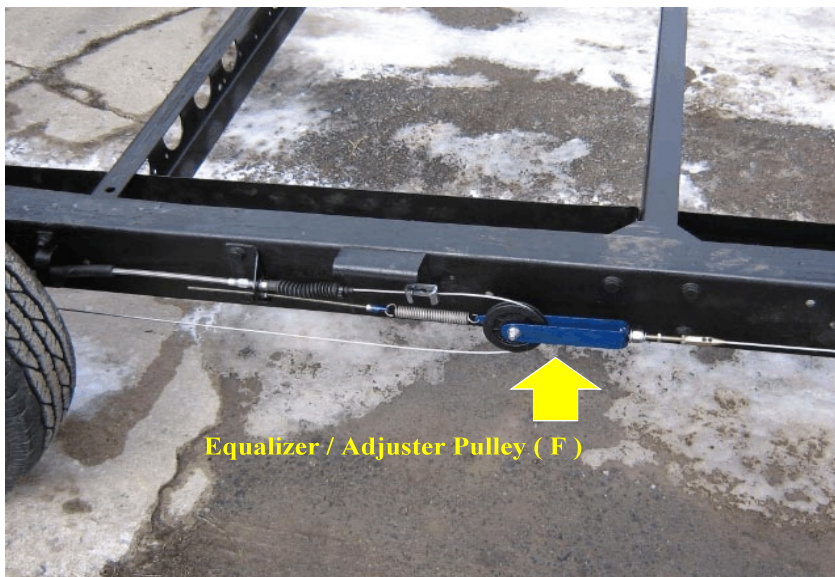
Bottom photo : Showing Equalizer / Adjuster pulley and retractor spring assembly and right side front conduit

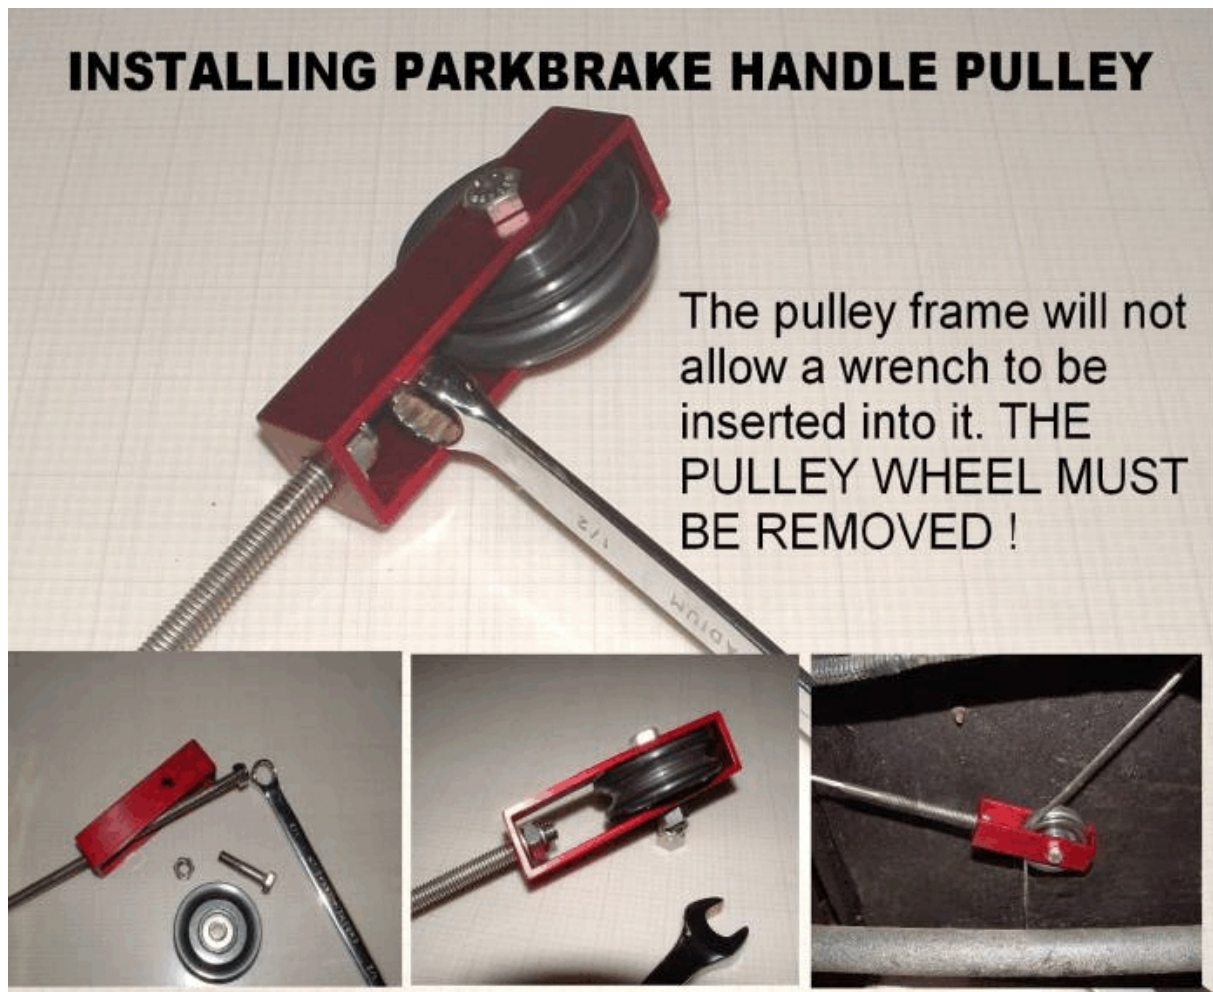
The red pulley assembly to connect the intermediate cable to the parkbrake(PB) handle cable must be installed on the PB handle cable stud (5/16"NC) before the intermediate cable is routed thru the intermediate cable guide pulley (D) over top of the right hand muffler and the red PB handle cable on the left hand side of the coach.

The stud hole is of sufficient size that the stud can be pushed out of the pulley frame so one can easily attach the washer and nut and then reinstall the pulley wheel as shown below.

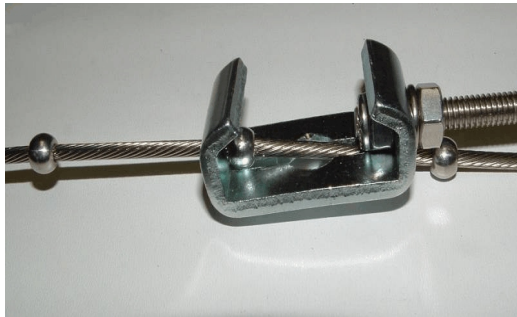
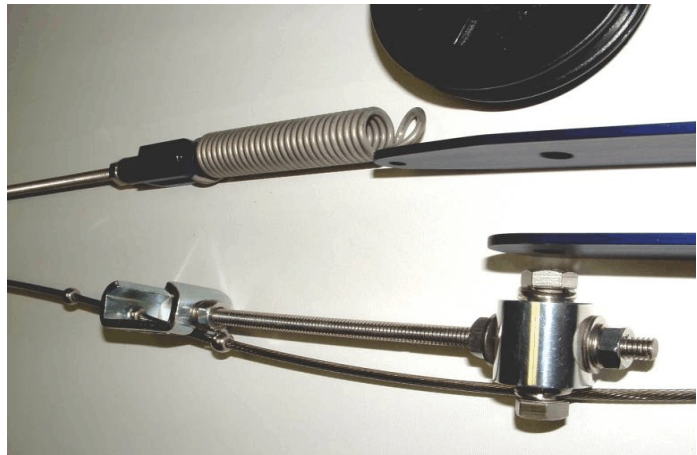
Configured to provide a 1 : 1 ratio of pull and distance (regular pulley wheel removed and replaced with yoke adapter & anchor connector)

Close up of anchor connector shown at right.

The kits are configured such that the customer has a choice of whether a direct pull on the intermediate cable represents a comparable pull in force and distance on the drum / caliper cable , ie. 1 : 1 ratio **or** the equalizer/ pulley adjuster yoke can be configured to provide a 2 : 1 ratio whereby the pull distance is doubled but the pull force is reduced to one half.

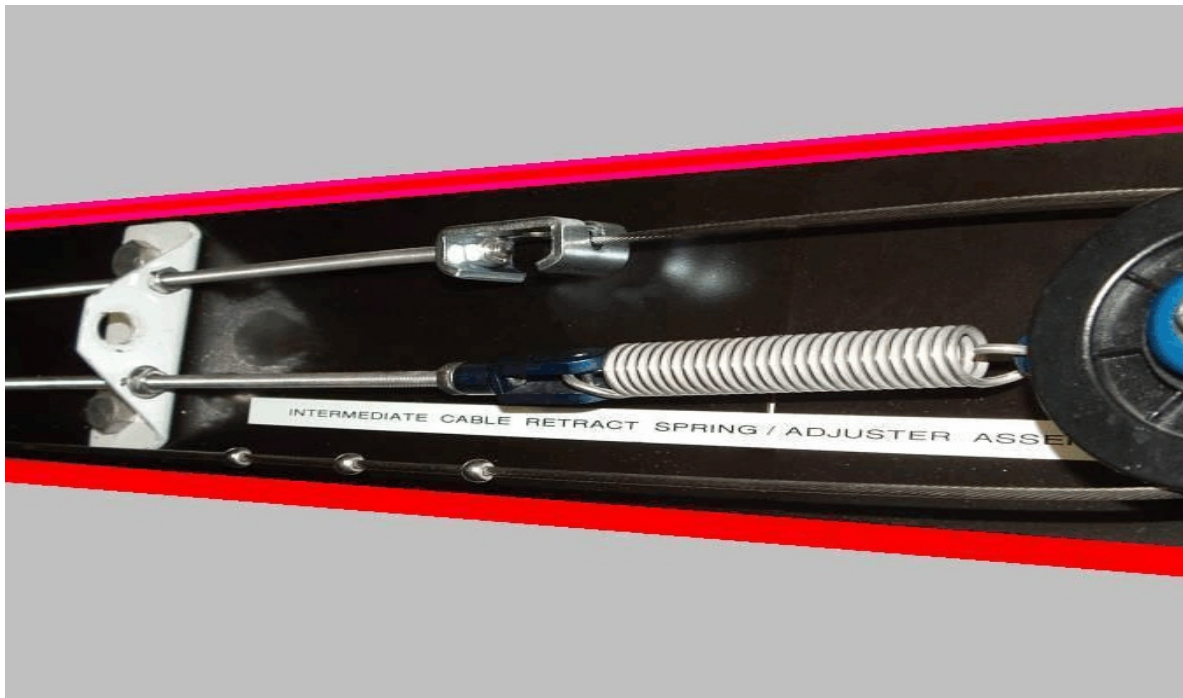
Configured for 2:1 ratio; double the pull distance & half the pull force.

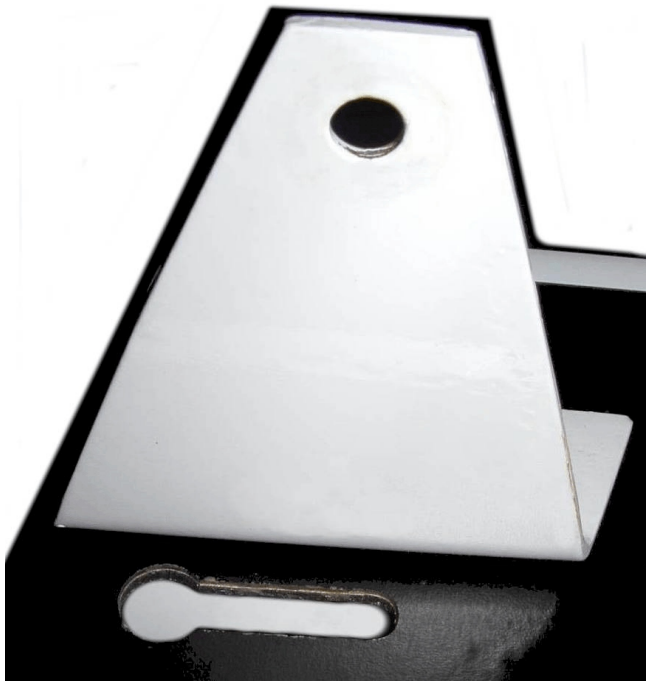
Figure 1

Profile of keyhole slot for intermediate cable at thru - frame pulley bracket

The front of the frame slot on each side of the coach will have to be enlarged from its current 3/8" dia. to just over 9/16" dia . this is best and easiest done with a small pneumatic angle grinder with a 3/8" tapered burr, it can be done with a file but its painful .

These enlargements are necessary to route the unions on the intermediate cable through on each side of the coach frame.

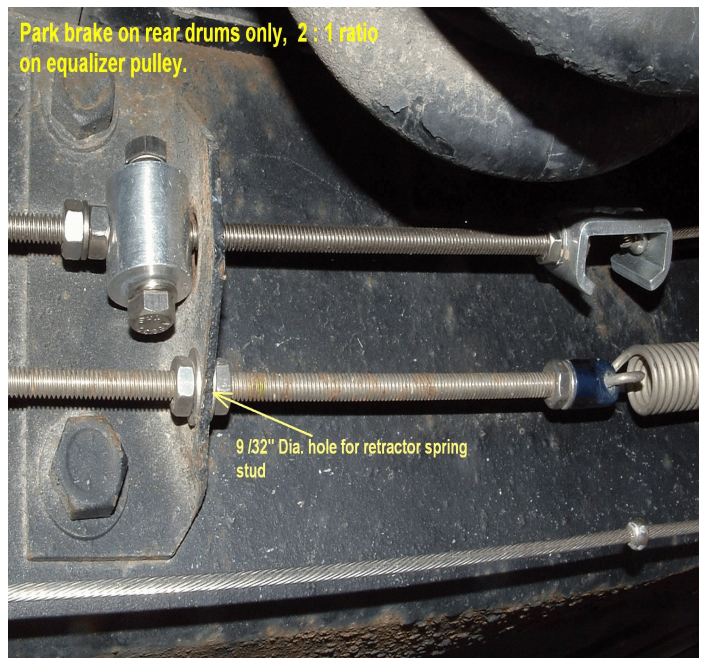
Figure 2

Forward frame bracket showing 9/32" dia. Hole for retractor spring stud

Also a 9/32" dia. hole has to be drilled thru the front bogie conduit frame mount bracket on each side of the coach. These are to accept the 1/4" stainless threaded adjuster rods from the intermediate cable retract springs.

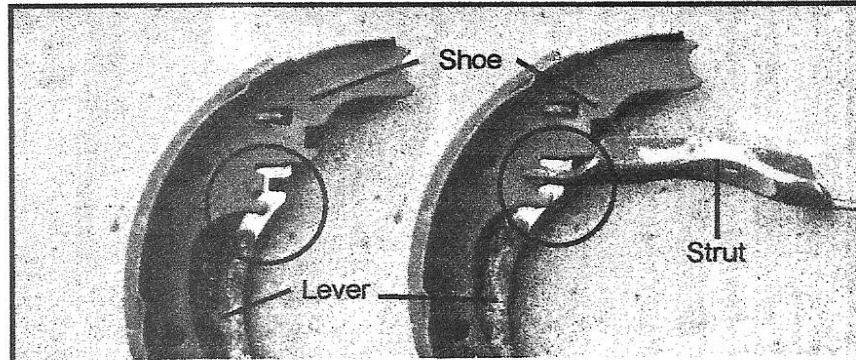
This is the correct relationship. Notice the position of notch in the lever designed to accept the strut, and the projection of the shoe circled on the left. Then the same view with the strut inserted on the right.

Carefully check that the notch in the parking brake actuator lever perfectly aligns with the appropriate tang on the brake shoe. Included is a picture and description from page 19 of Dec. '92 GMCMM by Ken Frey & Steve Galovic (Service Tip - Brakes), as well a note from Ken Frey in GMCMM , June '02 on problems with the " Parking Brake conduit guide loop". Both of these tips are important and should be addressed at this time. (**SEE FIG. 3 and 4**)

As a GMC servicing center Ken Frey, of Ken Frey Auto Service, has encountered several occasions of mismatch between the brake shoes and the emergency brake levers. The mismatch is created by mating early model parking brake levers with late model brake shoes, or visa versa. The problem seems to occur most often in 1976 Motorhomes, but could appear in any year coach. The easiest way to tell if you have the proper parts is by visual inspection. Ken has provided three sets of pictures one showing the correct association, and two incorrect possibilities. Operating with this mismatch causes very excessive brake wear and probable loss or partial loss of the parking brake. If the parts are properly matched and assembled there should be a very small amount of play (about 1/32 of an inch or so).

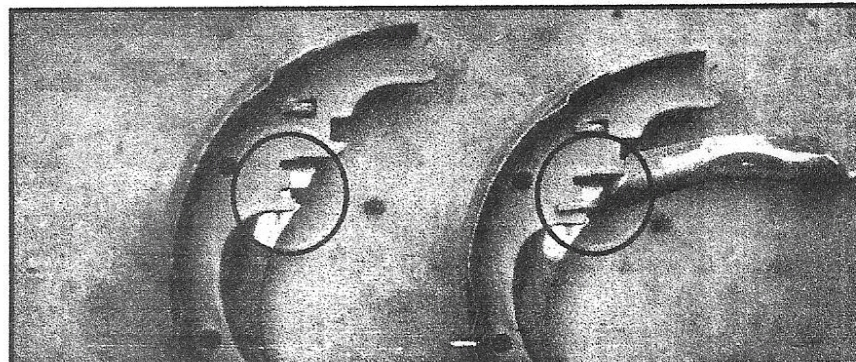
This is an incorrect relationship. Notice the position of notch in the lever designed to accept the strut, and the projection of the shoe circled on the left. The notch is too low. Then the same view with the strut inserted on the right showing an improper alignment.

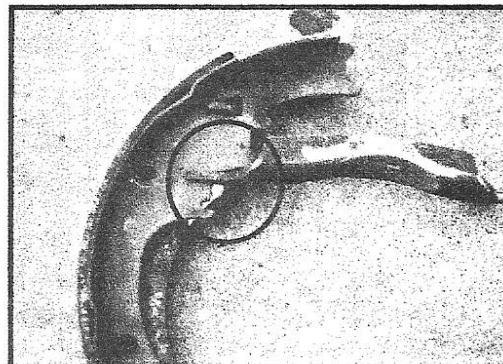
This is another incorrect relationship. Notice the position of notch in the lever designed to accept the strut, and the projection of the shoe circled with the strut inserted showing an improper alignment. The notch and strut are too high.

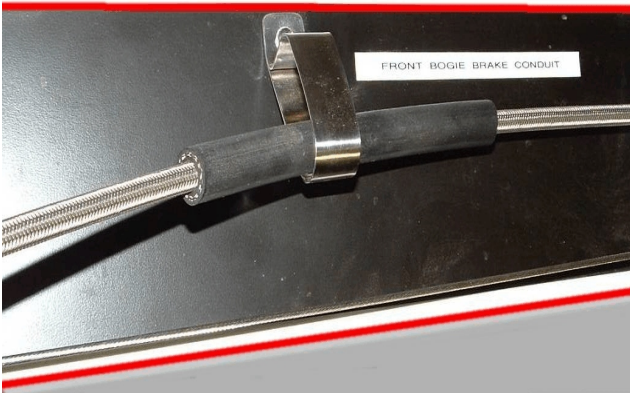
ORIGINAL CONFIG. OF GUIDE

In my work and travels, I have seen many parking brake cables damaged by the guide that holds them in place along the underside of the GMC Motorhome. This occurs because the guide (or hanger) does not allow enough space for the cable to “float” freely. Therefore, the brake cable tends to rub against the guide, which over time causes damage. Removing the original guide and either straightening, modifying or replacing it can achieve twice the travel and can easily remedy this problem.

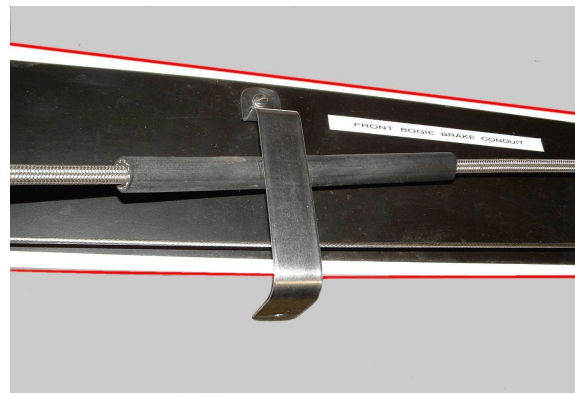
MODIFIED CONFIG. OF GUIDE

In this case , we used a 3 /4" strap of scrap metal. Two 1/4" bolts, nuts and a couple of large washers fastened into two holes drilled into the frame for mounting the new guide completed the job - no more damage.

Quite often it's impossible to remove the frame fasteners securing this bracket, if the frame fasteners are corroded and cannot be removed then cut the inside of the strap near the fastener and simply bend it down as shown in the modified configuration or bend it up out of the way completely and don't use it at all. Due to the restrictive nature of the OEM configuration more severe conduit damage could occur than not having the bracket at all.
